District Safety Program

Maintenance Operations

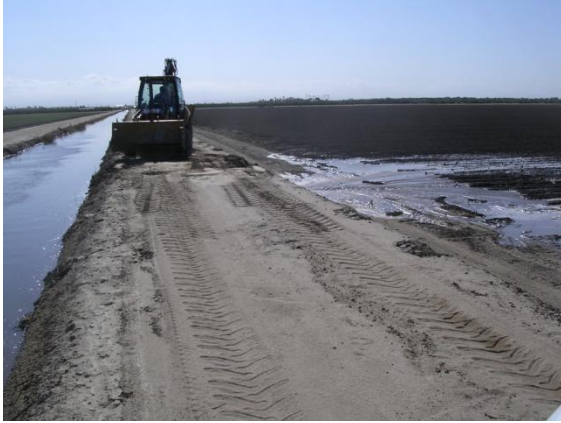
- District staff has been busy addressing wash-ins and wash-outs during the initial delivery of irrigation supplies. Of notable mention were canal breaches at Main Intake Canal at Sheep Camp Bridge, Main Intake Canal from the Kaweah Delta Water Conservation District to the Cameron Box structure, Main Intake Canal at the Parigen Property and Road 148 at Summers Property.

District staff repairing one of the many canal breaches that occurred within the system.

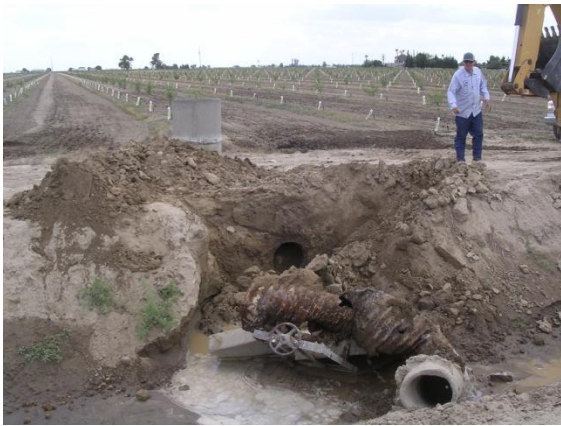
District staff repairing a failed canal turnout at the Bassett Ditch.

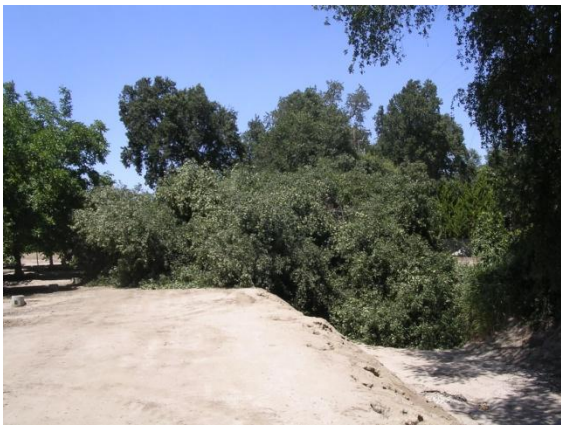
- The District had several oak trees that were down or had large branches that broke in the recent wind storms. District staff moved quickly to remove the trees and the fallen branches so that canals would not be obstructed from flow.

Fallen oak tree in canal.

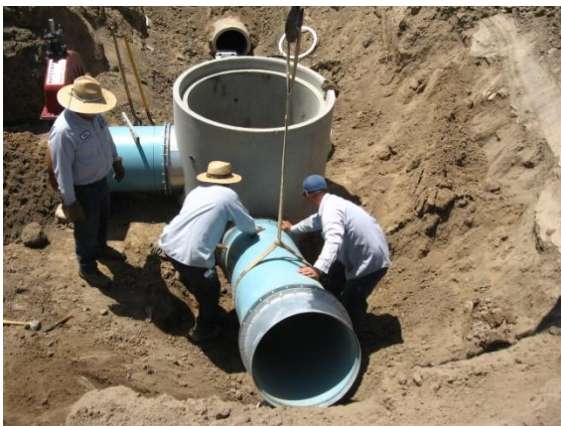
Installation of connection manhole at Area 10 and the new 24" PVC pipeline.

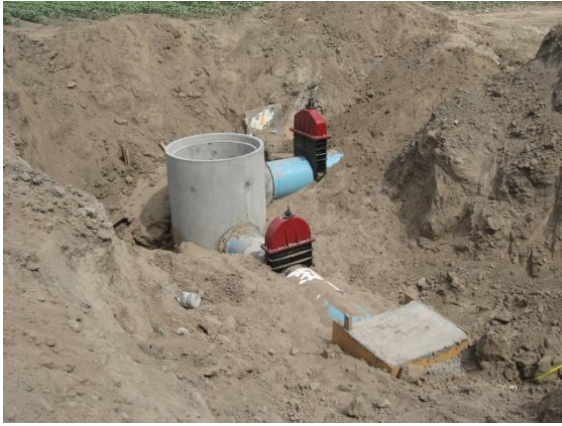
24" PVC pipeline connection to Area 10 Pipeline.

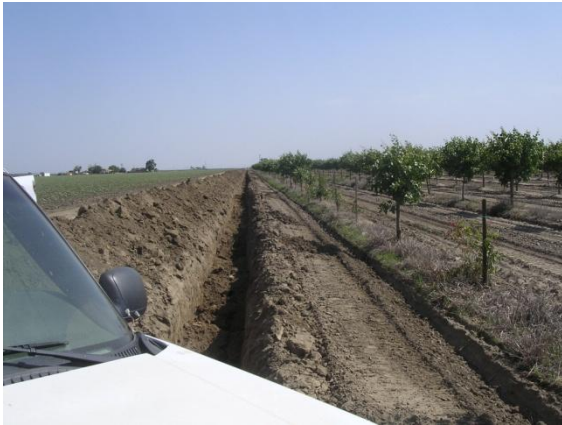
24" PVC Pipeline trench.

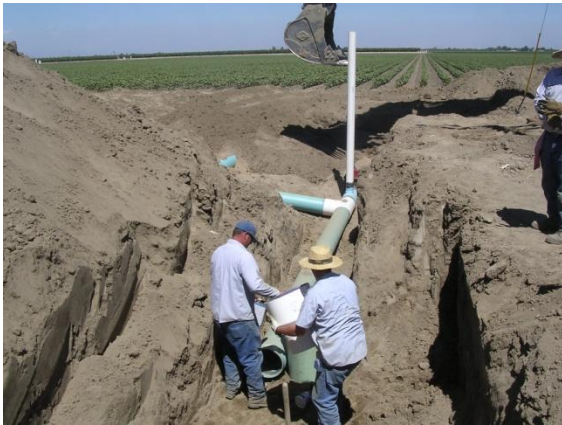
24" PVC pipeline connections to existing turnouts.
