# Tulare Irrigation District Operation & Maintenance Report

2012 Quarter 2

Prepared By:  
Aaron Fukuda & Gene Bessinger  
June 29, 2012

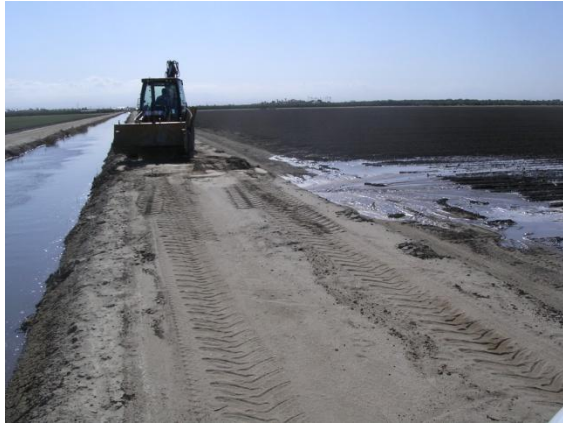
- District staff has been busy addressing wash-ins and wash-outs during the initial delivery of irrigation supplies. Of notable mention were canal breaches at Main Intake Canal at Sheep Camp Bridge, Main Intake Canal from the Kaweah Delta Water Conservation District to the Cameron Box structure, Main Intake Canal at the Parigen Property and Road 148 at Summers Property.

District staff repairing one of the many canal breaches that occurred within the system.

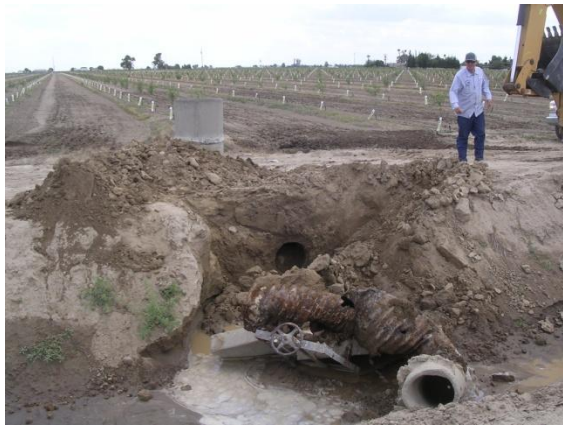
District staff repairing a failed canal turnout at the Bassett Ditch.

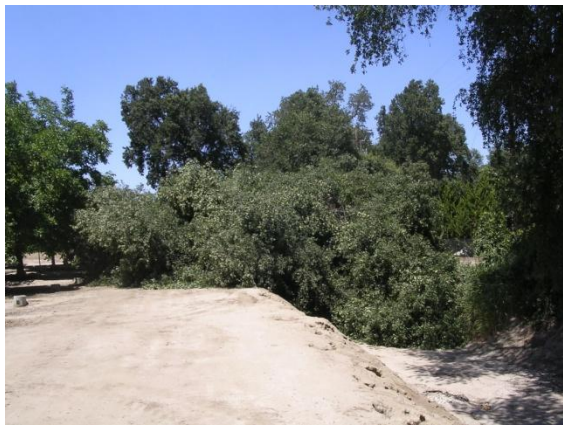
- The District had several oak trees that were down or had large branches that broke in the recent wind storms. District staff moved quickly to remove the trees and the fallen branches so that canals would not be obstructed from flow.

Fallen oak tree in canal.

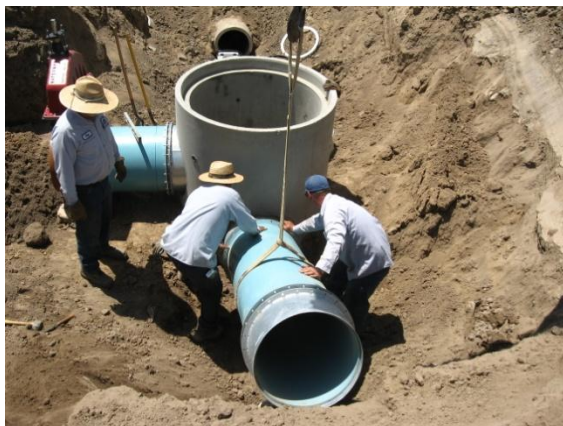
Installation of connection manhole at Area 10 and the new 24" PVC pipeline.

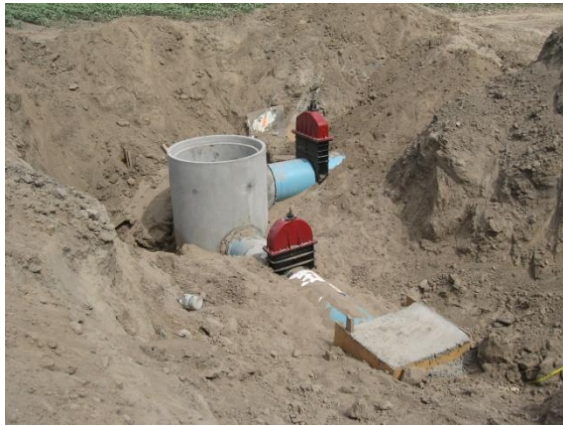
24" PVC pipeline connection to Area 10 Pipeline.

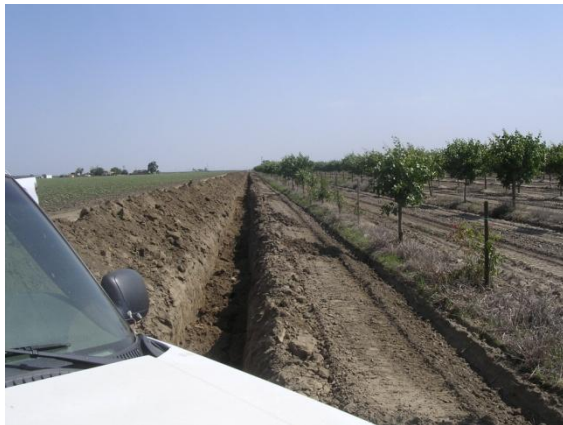
24" PVC Pipeline trench.

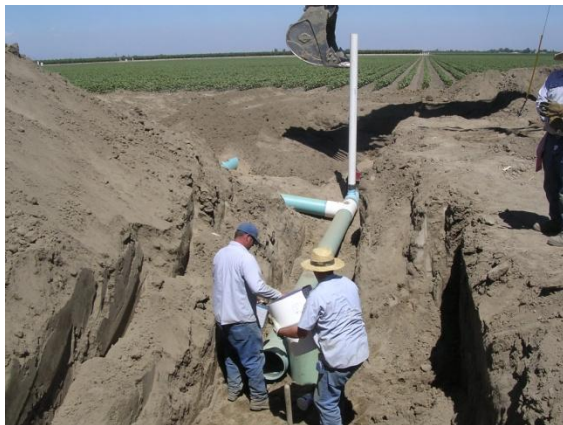
24" PVC pipeline connections to existing turnouts.
