Tulare Irrigation District Operation & Maintenance Report

2012 Quarter 2

Prepared By:
Aaron Fukuda & Gene Bessinger
June 29, 2012

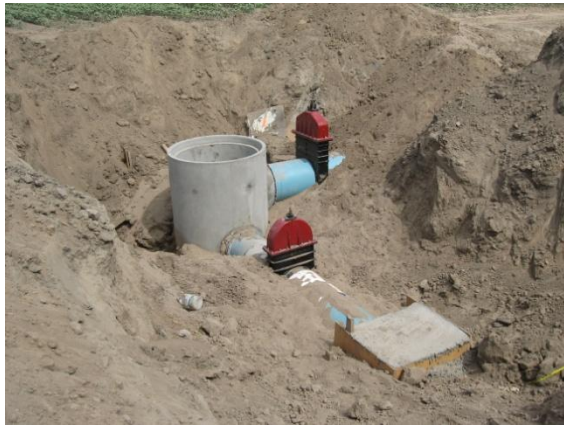
24" PVC pipeline connection to Area 10 Pipeline.

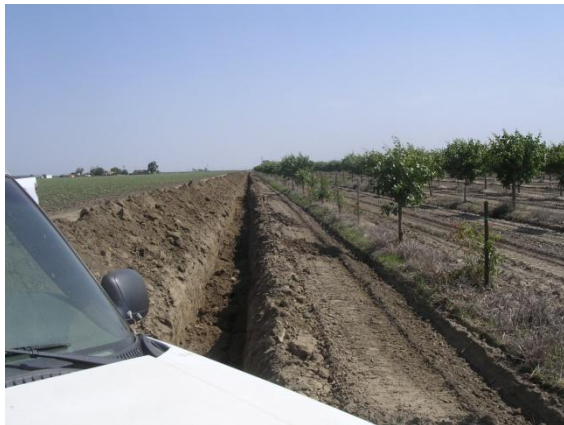
24" PVC Pipeline trench.

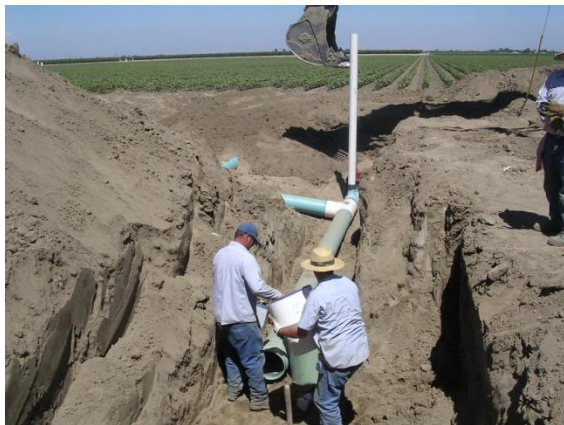
24" PVC pipeline connections to existing turnouts.
