# Tulare Irrigation District Operation & Maintenance Report

2012 Quarter 2

Prepared By:  
Aaron Fukuda & Gene Bessinger  
June 29, 2012

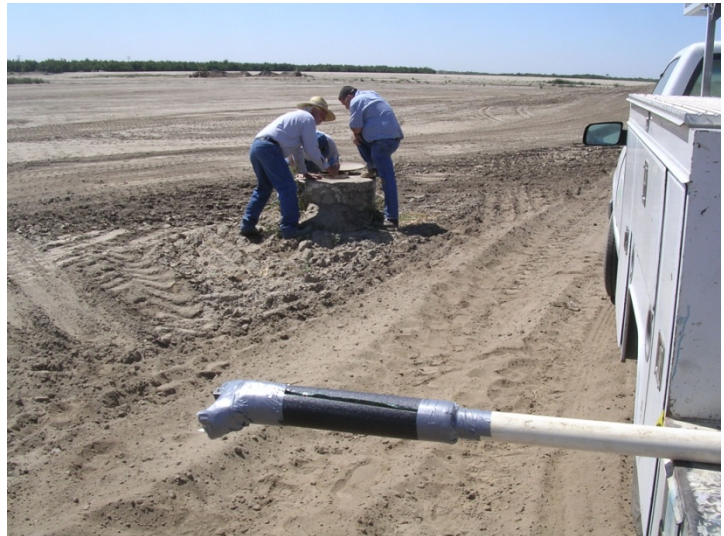
- District staff has been busy addressing wash-ins and wash-outs during the initial delivery of irrigation supplies. Of notable mention were canal breaches at Main Intake Canal at Sheep Camp Bridge, Main Intake Canal from the Kaweah Delta Water Conservation District to the Cameron Box structure, Main Intake Canal at the Parigen Property and Road 148 at Summers Property.

District staff repairing one of the many canal breaches that occurred within the system.

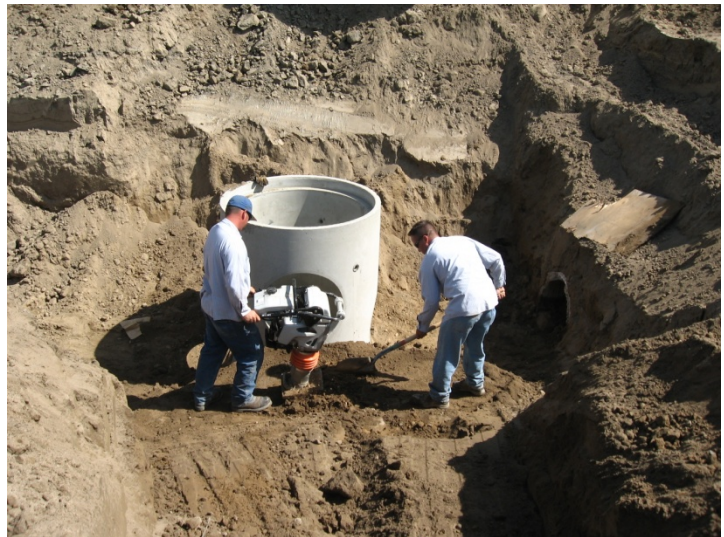
District staff repairing a failed canal turnout at the Bassett Ditch.
