Tulare Irrigation District Operation & Maintenance Report

2012 Quarter 1

Prepared By:
Aaron Fukuda & Gene Bessinger
March 31, 2012

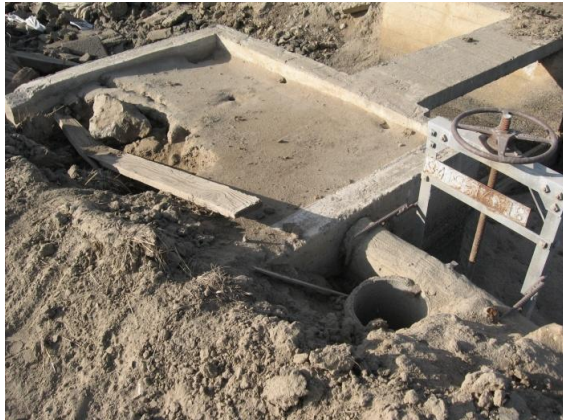
The District conducted a safety assessment of District structures and this is an example of earthwork that is compromised.

- The District currently has several employees that have been restricted to “light-duty” work due to injuries. In order to effectively utilize their time, Mr. Bessinger has assigned these individuals to conduct various District assessments. One of the assessments conducted was an inspection of District structures for safety issues such as tripping hazards and large step requirements. The other study conducted was a District-wide assessment of canal gates to identify maintenance issues that need to be addressed. The gate inspections that were conducted were summarized into a work-list that provided maintenance staff with immediate gate repairs and future assessment and repairs. District staff is currently working on repairing gates that were identified as a priority.

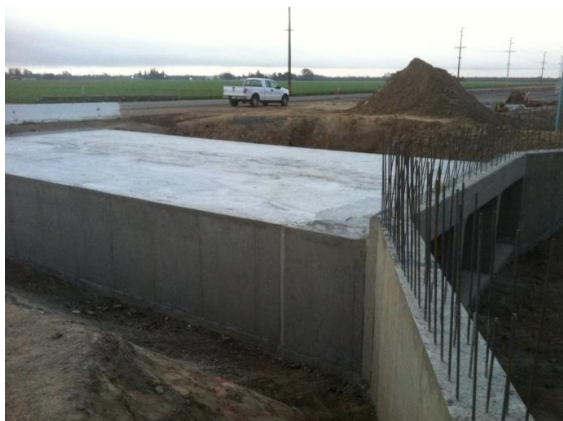
New culvert extension at Northbranch Canal and Road 108. Construction by Teichert Construction and inspected by District (Wayne Fox).

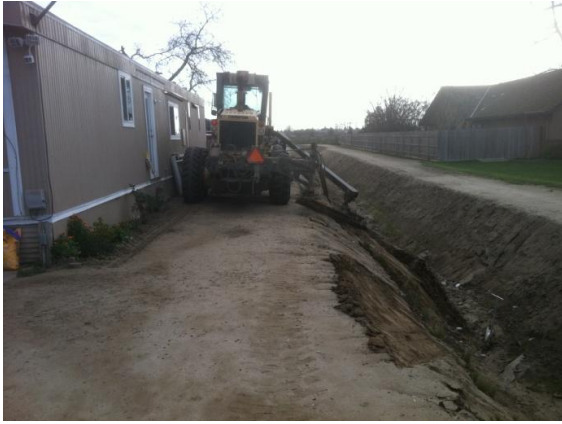
Canal sloping on Sand Ditch at West Street (Road 92). Coordinated with new landowner to regain access to Sand Ditch after 25+ years of restricted access.

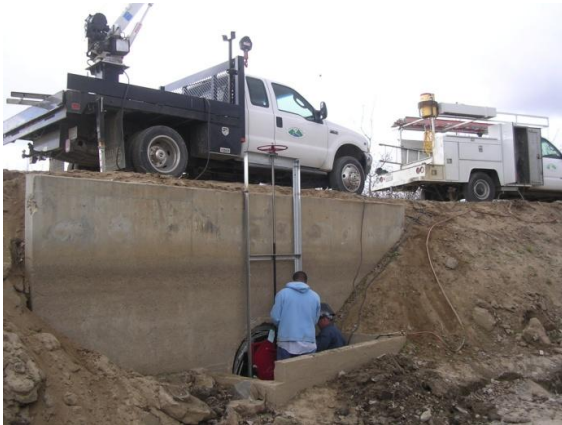
Replacement of canal gate at the headworks of the V-Line Ditch.

- District staff has begun upstream canal levee repairs. Numerous locations have had wash-ins and ruts that require attention.
- The canal gate at the head of the V-Line Ditch was removed and replaced with a new canal gate.

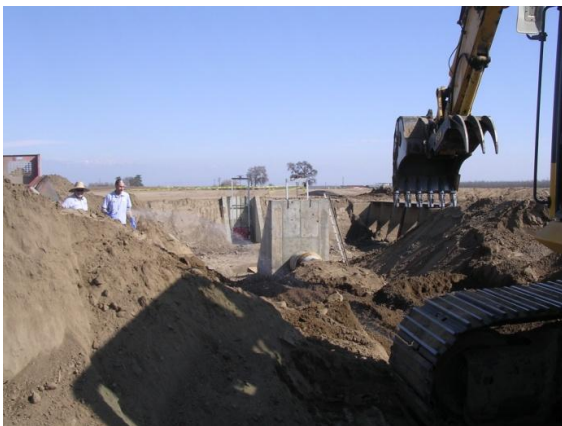
Installation of inlets to Cell #2 and Cell #3 at Swall Basin.

- Construction of the inlet structures for Cell #2.
- Construction of the inlet structures for Cell #3.
- Removal of existing irrigation pipeline system on Cell #3.
- Removal of topsoil from Cell #3 and placement on the adjacent property (Kumar Property).
- Construction of the east embankment of Cell #3.
- Movement of excavated material to adjacent property (Kumar Property).

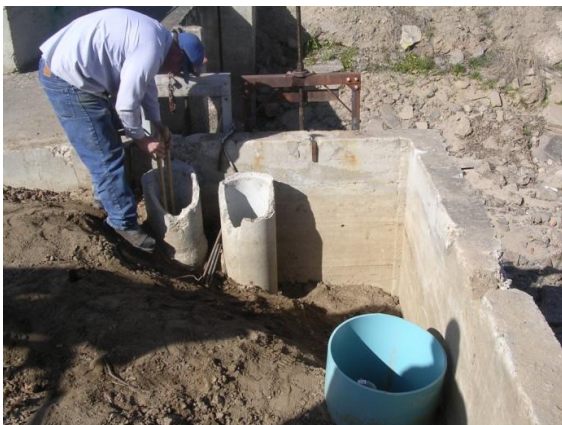
Measuring well maintenance.

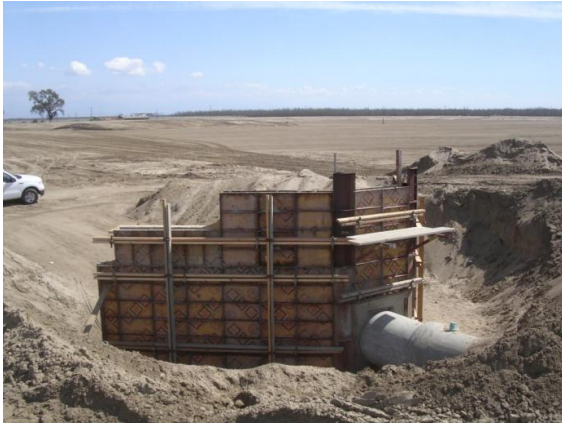
Cell #2 inlet structure.

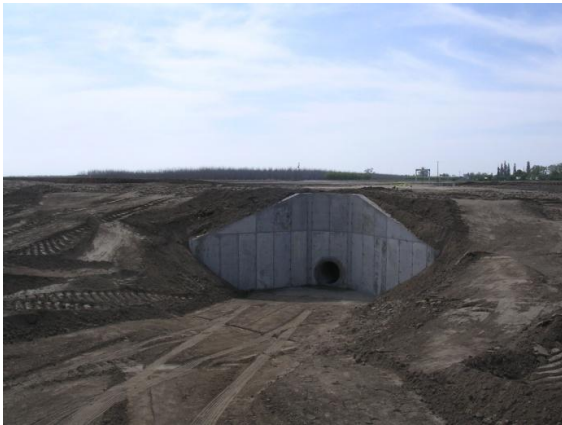
Completed Cell #2 inlet structure.

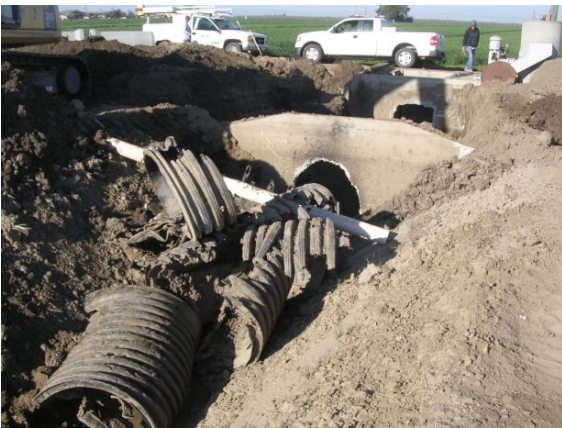
Bender Ditch culvert replacement.

- An HDPE culvert crossing on Bender Ditch was replaced with a new concrete culvert crossing.
- A culvert crossing that failed on the Northwest Ditch was replaced by a new concrete culvert crossing.

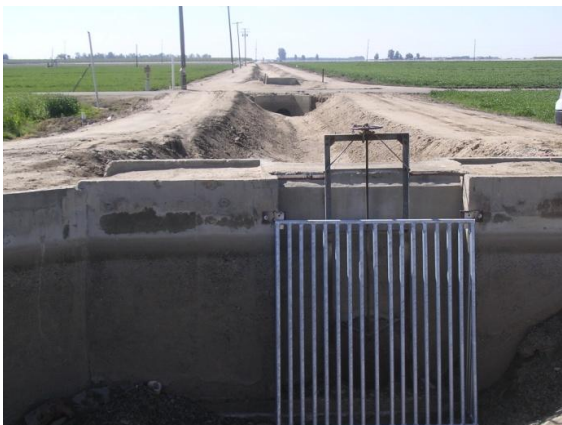
New trash rack installation at Bassett Ditch.
